## Case Study - Product: RR401 | 4lb Concrete Raising Foam

**Project Location:** Hwy. 141 & Hwy 22 Oconto, Wisconsin

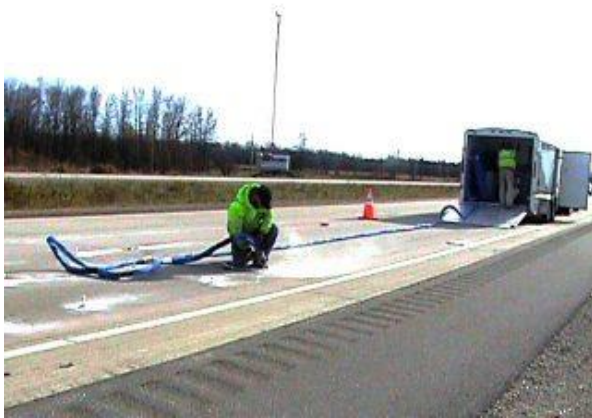
There was a low spot across the 45' span of Hwy. 22 off-ramp roadway from Hwy. 141. Traffic would dip as it traveled across the problem area, causing safety concerns to the county highway department.
